INJURY BIOMECHANICS RESEARCH
Proceedings of the Twenty-Seventh International Workshop

A Pilot Study of Shoulder Trauma Produced by Lateral Impacts

J. H. Bolte, IV, M. H. Hines, J. D. McFadden, R. A. Saul

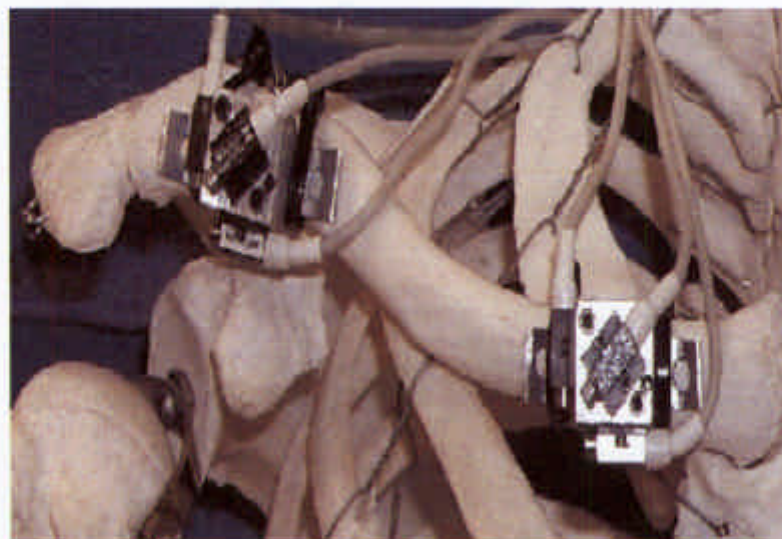
FIG 1. Triaxial Accelerometer Mounts on the Lateral and Medial Thirds of the Clavicle

The accelerometer mounts positioned on the lateral and medial extremes of each clavicle were secured using plastic wire ties, see FIG. 1 below. The base of each mount was curled up on the end to keep the mount from slipping out from under the wire ties during impact. The position of the accelerometer mounts on the lateral and medial thirds of each clavicle was important in two regards. First, the output from the accelerometer mounts defined the movement of the clavicle during the lateral impact. Second, the output from the medial mount along with the output from the sternum mount monitored movement at the sterno-clavicular joint. Likewise, the outputs from the lateral end mount and the acromion process mount provided information on movement at the acromio-clavicular joint.

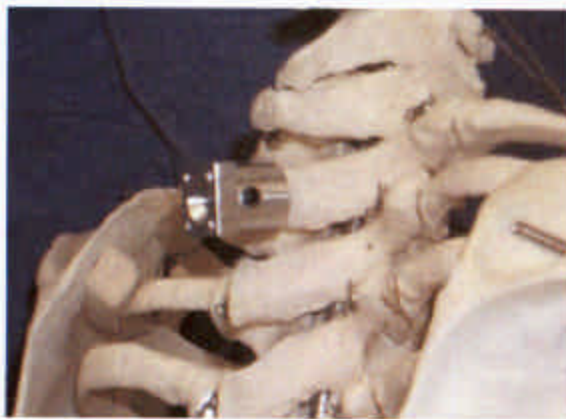
FIG. 2. Triaxial Accelerometer Mount on the First Thoracic Vertebrae

The triaxial accelerometer mount used on T1 was developed to decrease bleeding during the testing procedures. The design of the mount, similar to a thimble, allowed for it to slide over the top of the spinous process, see FIG. 2 below. A standard two inch drywall screw was tightened into the spinous process through the end of the mount, while two set screws were used on the sides of the mount to limit any rotation during impact.

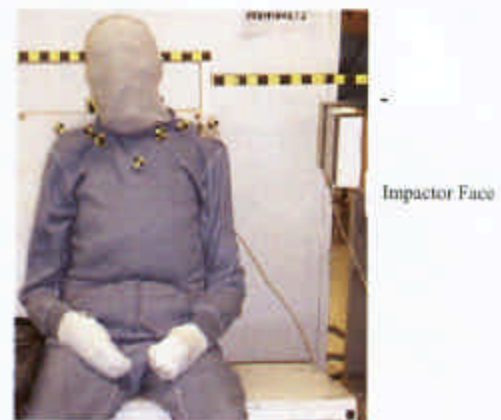
FIG. 3. Cadaver Positioning on the Impactor Seat

Pre-Test. Following instrumentation, the cadaver was dressed in a suit of blue thermal underwear. The hands and feet were enclosed in white socks, and the head and neck were covered with a hood of thermal underwear, thus eliminating the possibility of identification of the donor. After the cadaver was suited for testing, the cadaver's upper limbs were exercised through their range of motion to eliminate rigor mortis. The subject was then positioned on the impactor seat with the center of the ram in line with the approximate center of the gleno-humeral joint (FIG. 3).

Photographic target pins were inserted into the triaxial accelerometer mounts after the cadaver was positioned. The purpose of the photographic pins was threefold. First, the pins enabled positioning measurements of each accelerometer mount to be recorded for subsequent analysis. Secondly, the angles of the photographic pins were measured to determine how far off axis each accelerometer was pointing prior to impact. Finally, the photographic pins were used to support camera targets, see FIG. 3. The movement of these targets during impact was tracked using two high speed digital cameras.
